Construction Report no.2

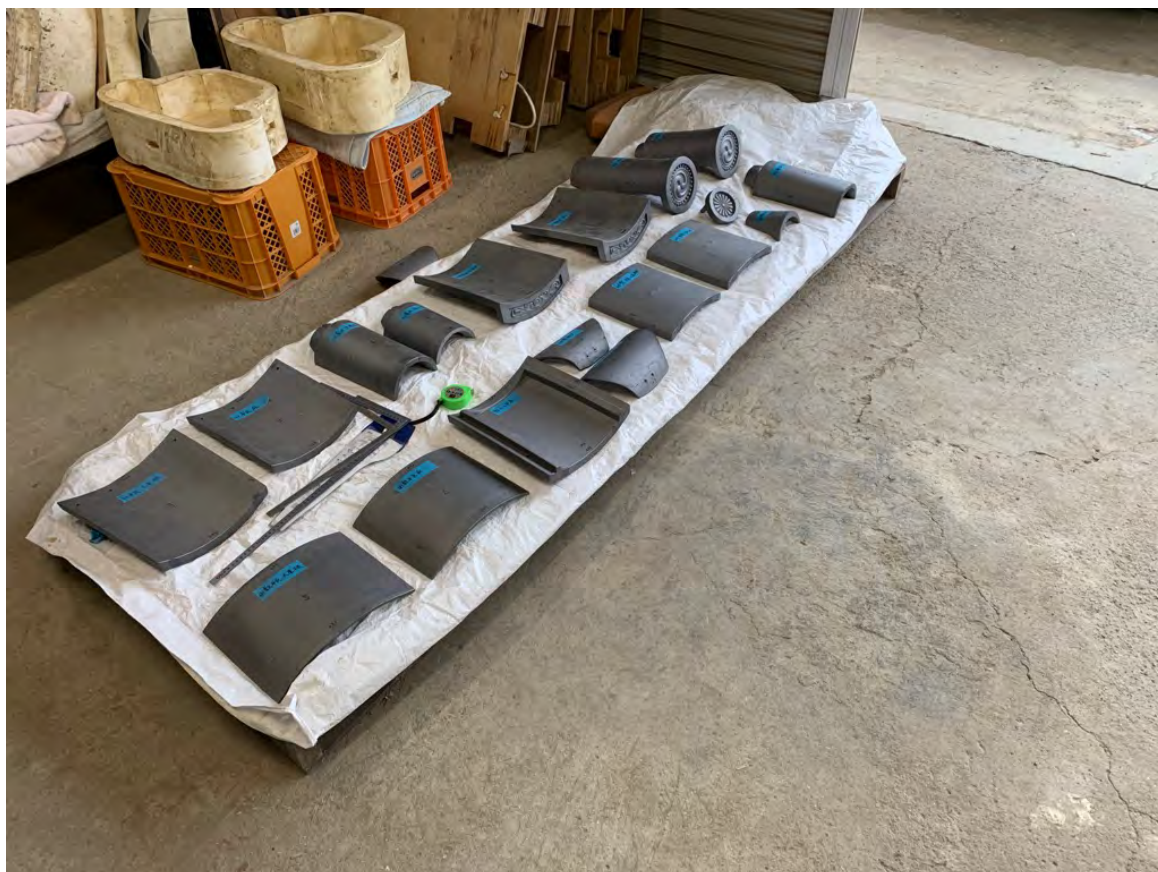
Inspected tile prototypes.

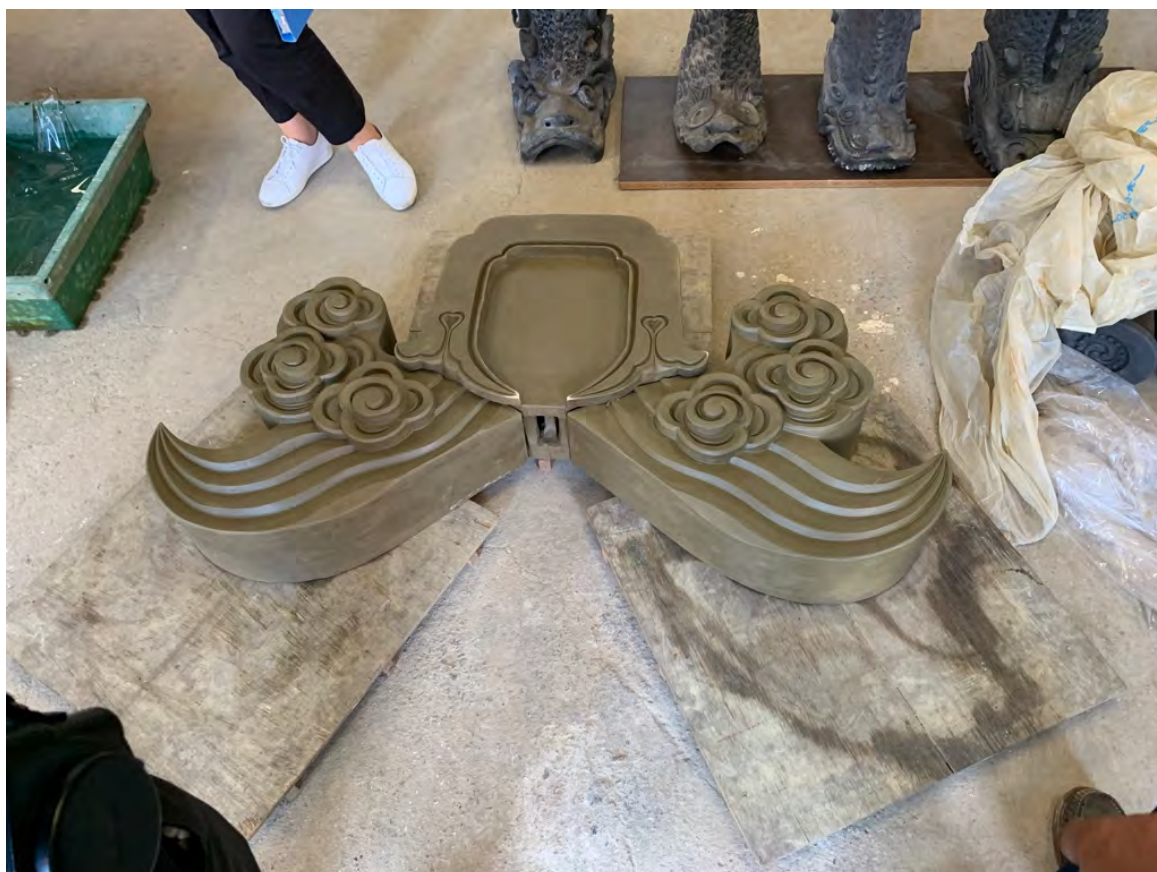
The clay mold to confirm the design of shachigawara restored from the old photographs.

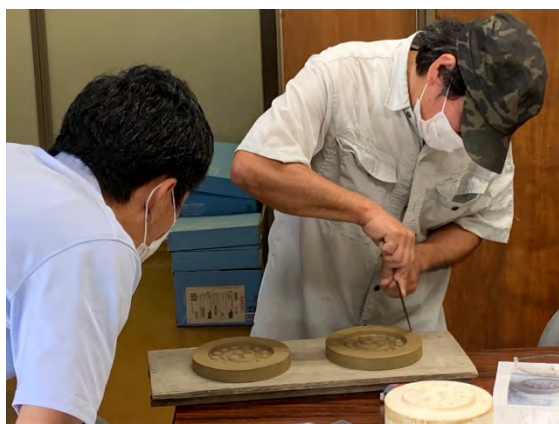
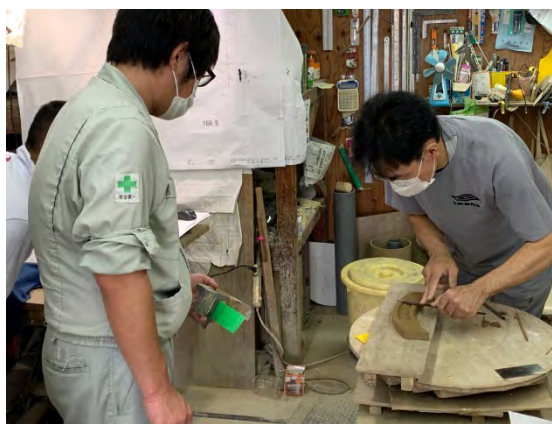
As well as the above-mentioned, the clay mold of onigawara.

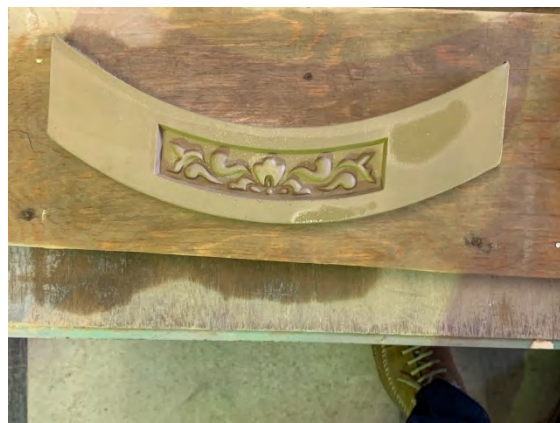
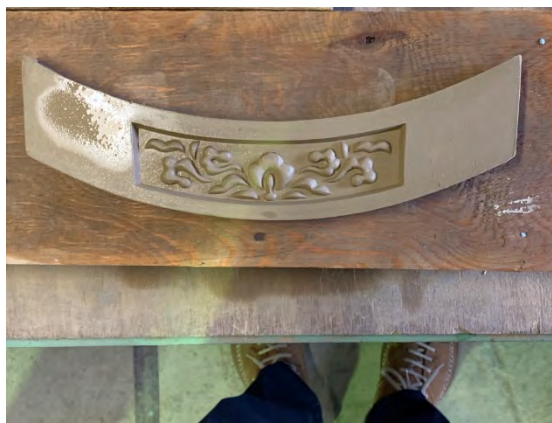
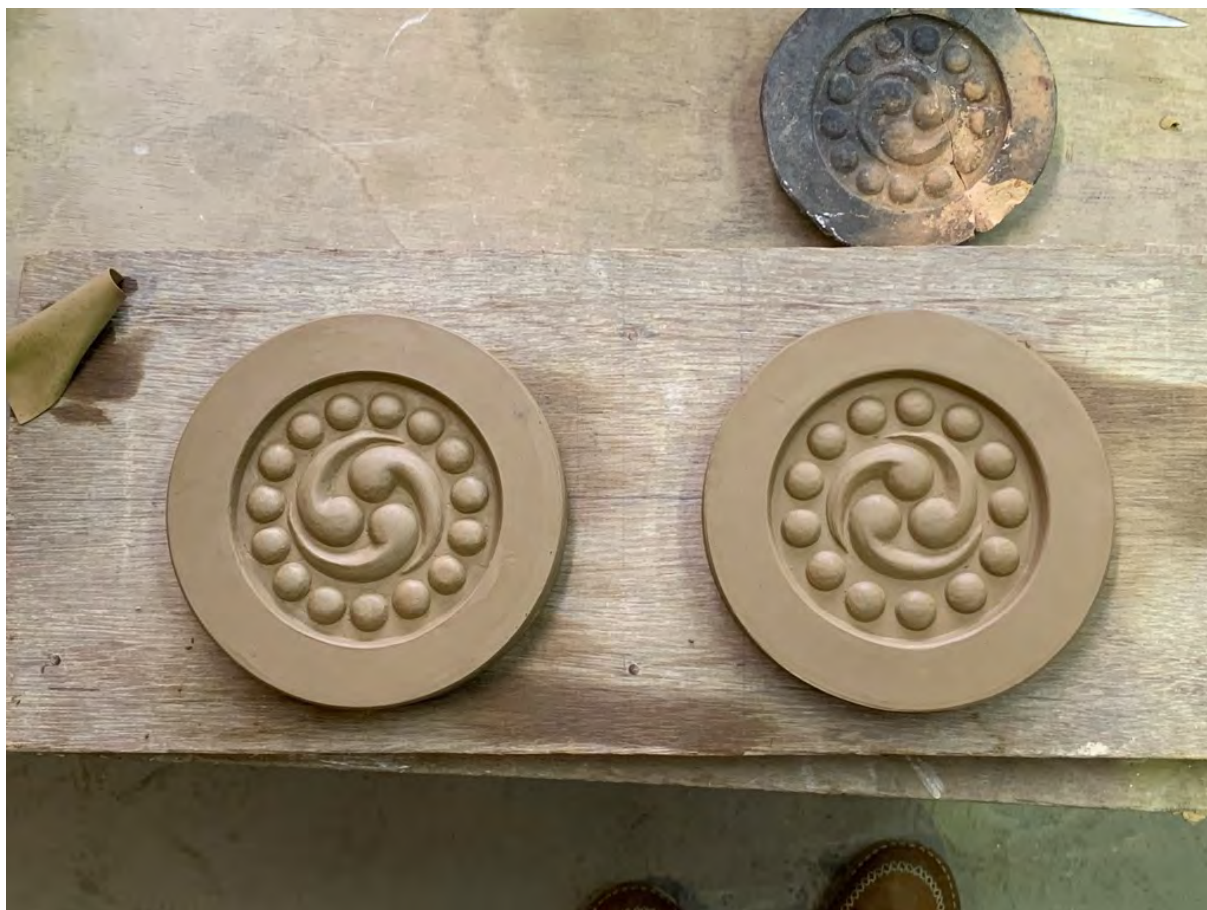
Checking the design of gatou (the tip of the eaves-end tile) and making corrections.

The design of gatou is produced with reference to the discovered item from the excavation survey.

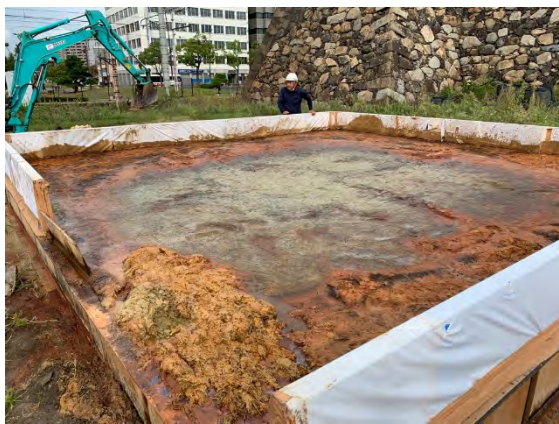
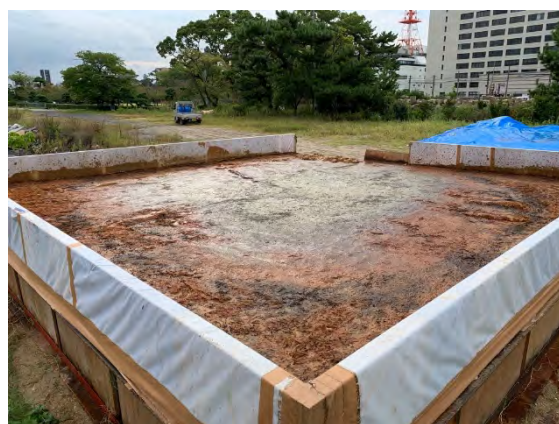
The second mixing of wall clay made at the end of June was done. It is the situation before it.

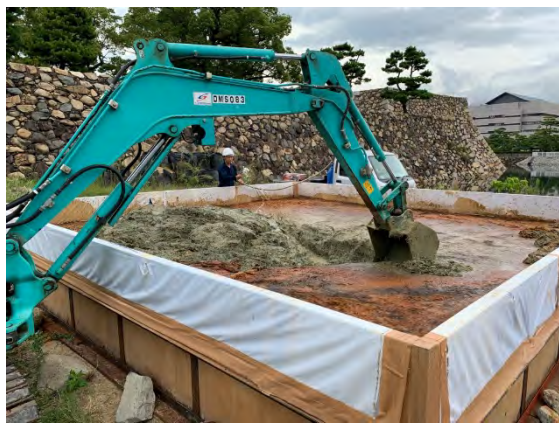
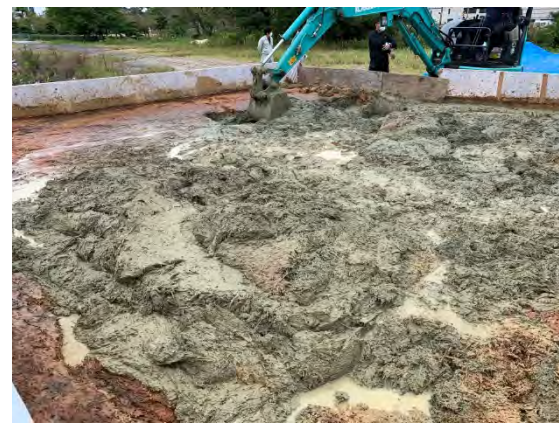
It is being mixed while adding water.
The fermentation of straw susa (crack prevention material) has progressed.

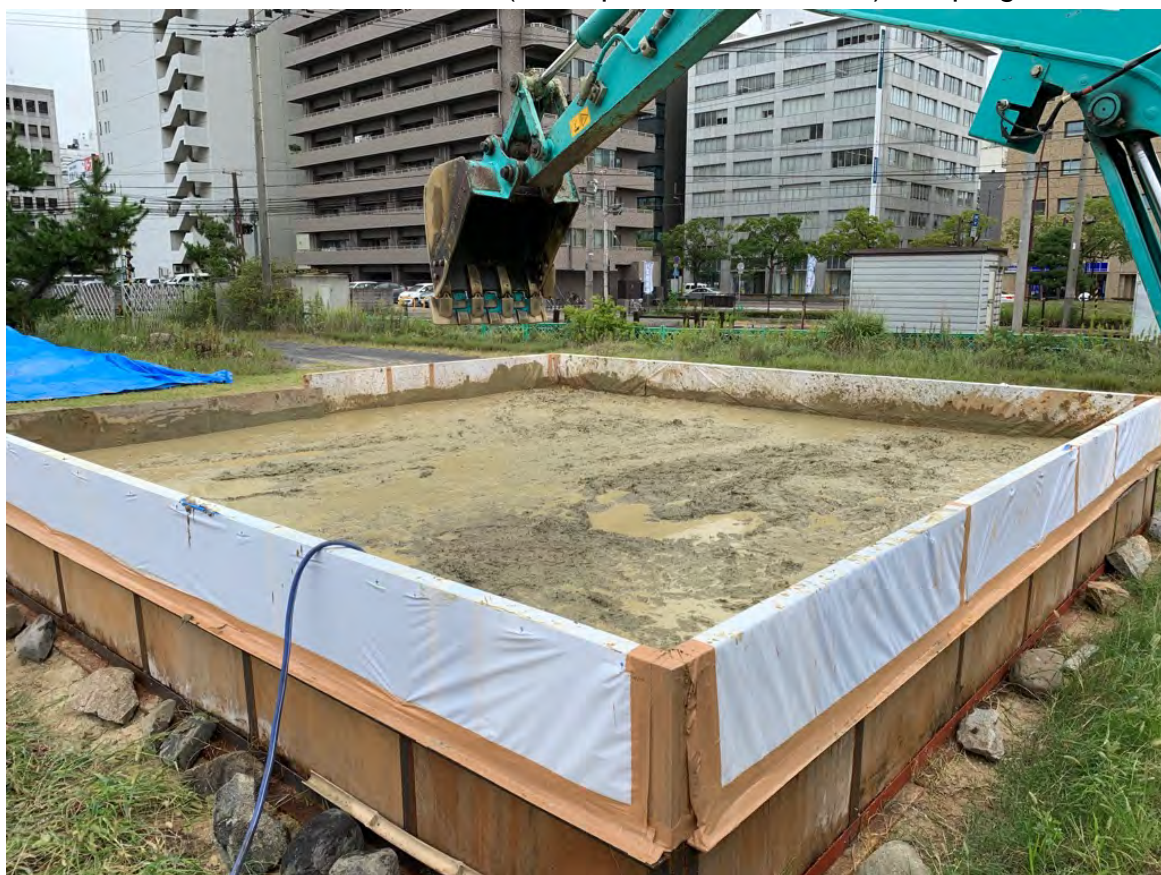
Mixing completed. After a further curing period, it will be mixed again.
