Construction Report no.3

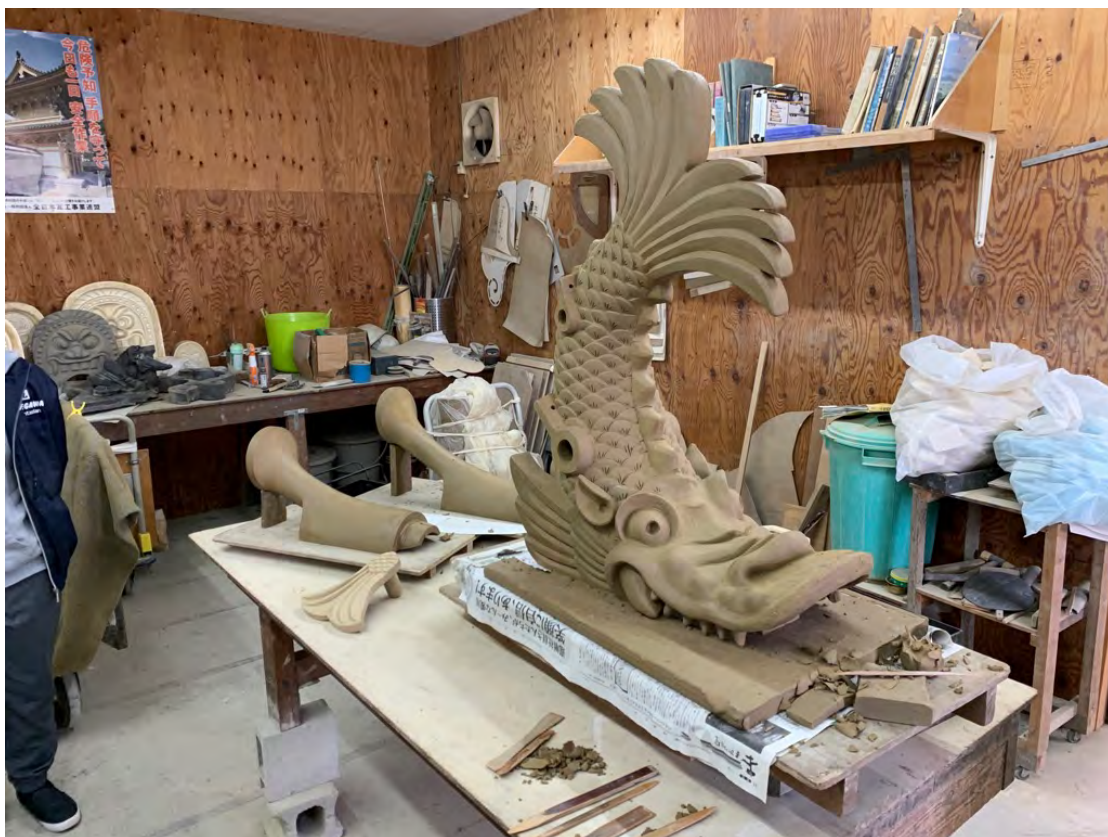
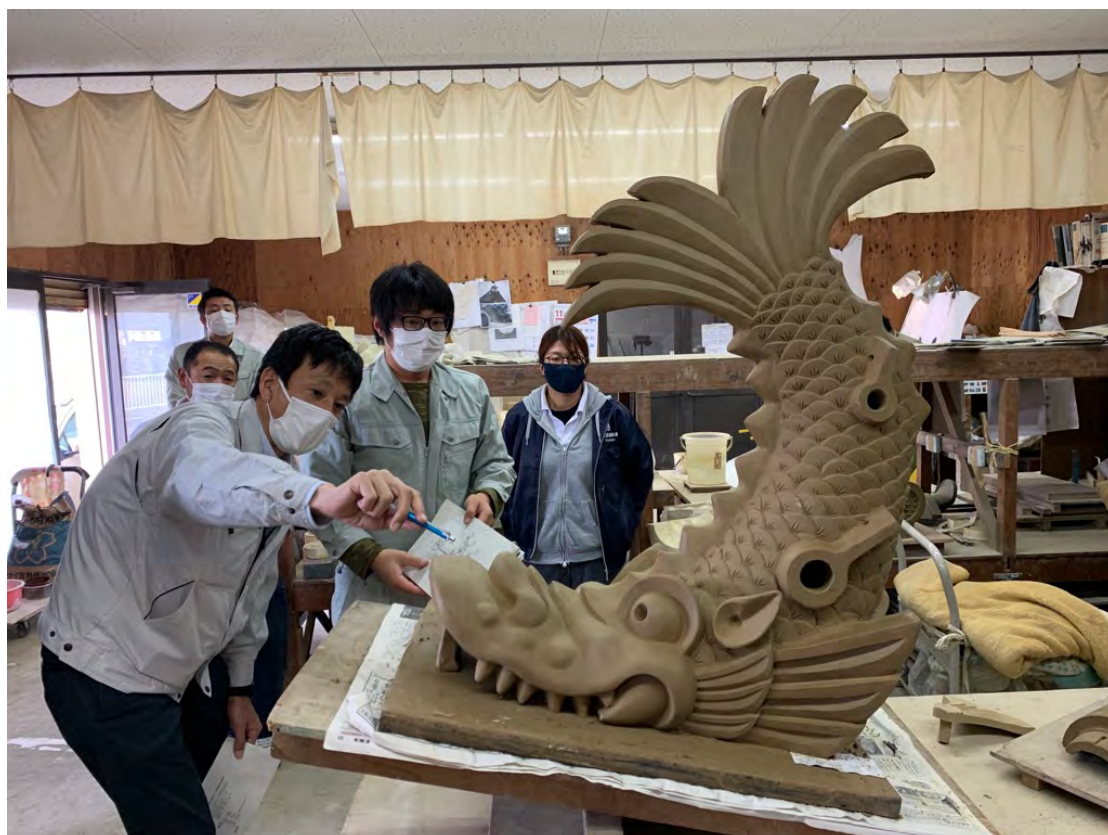
We inspected a prototype made based on the shachigawara clay mold confirmed with half body in September.

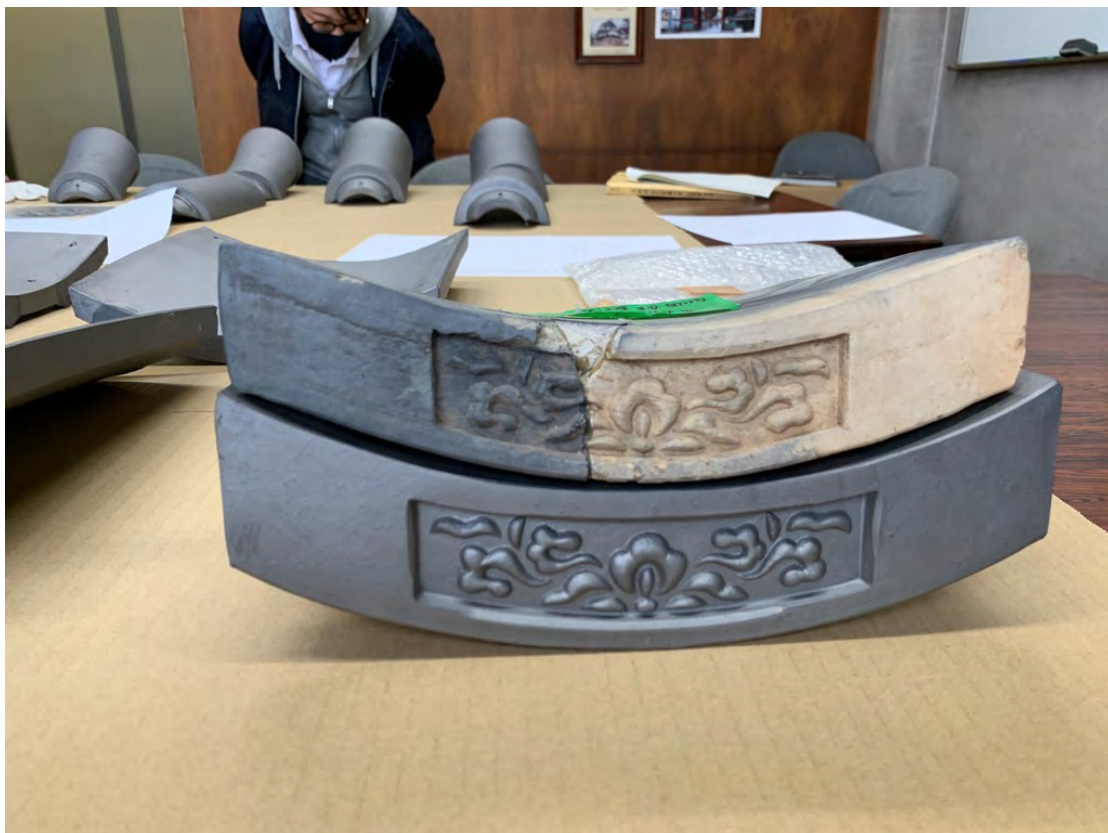
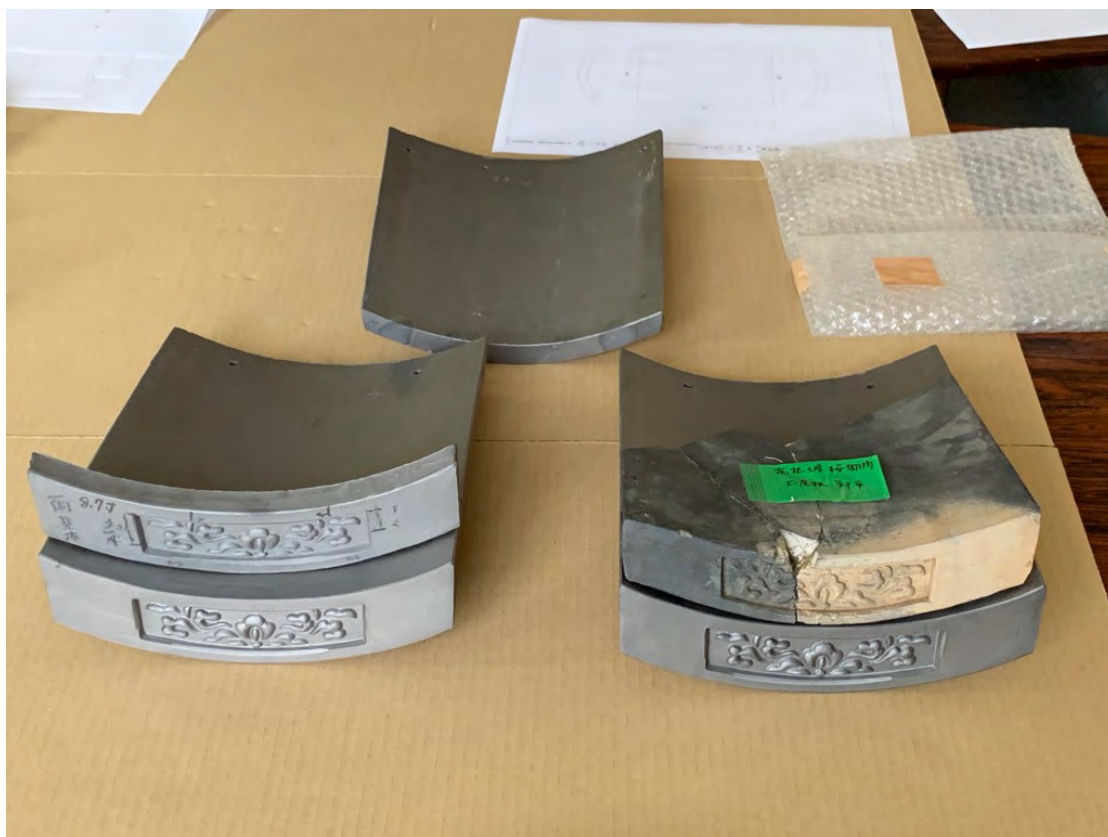
Similarly, we inspected prototypes of tiles baked based on the gatou confirmed in September.

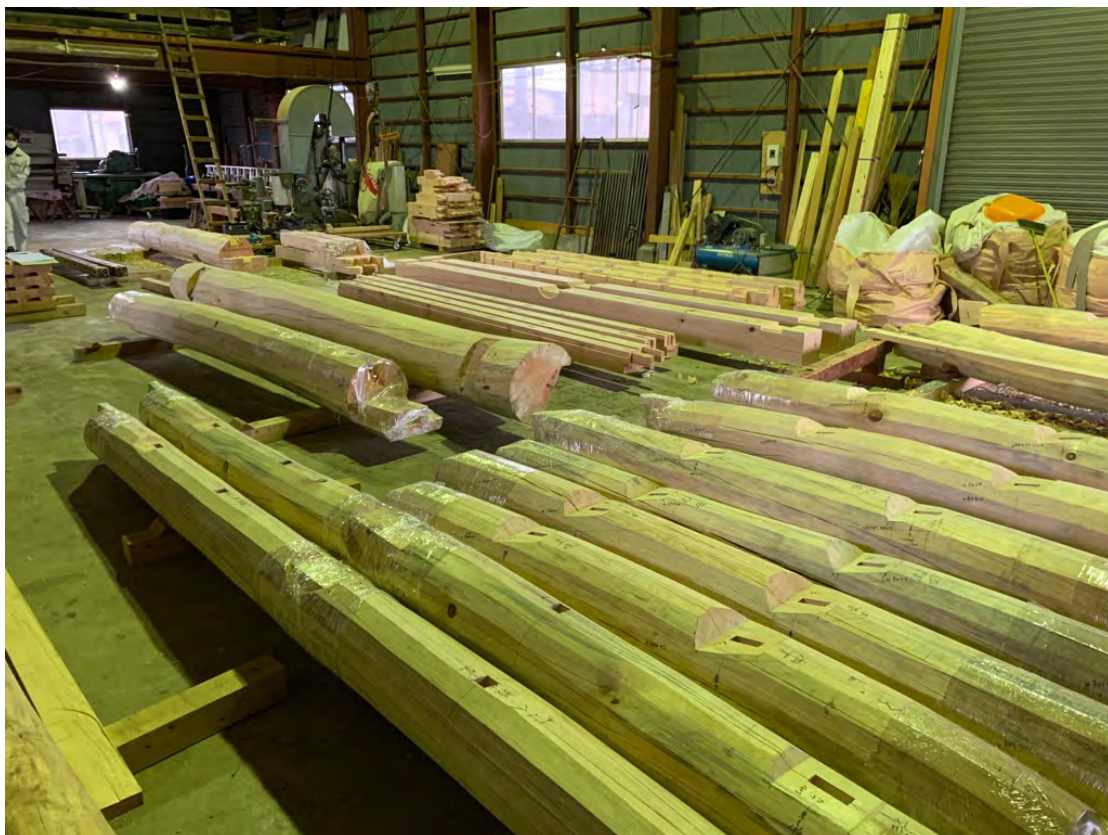
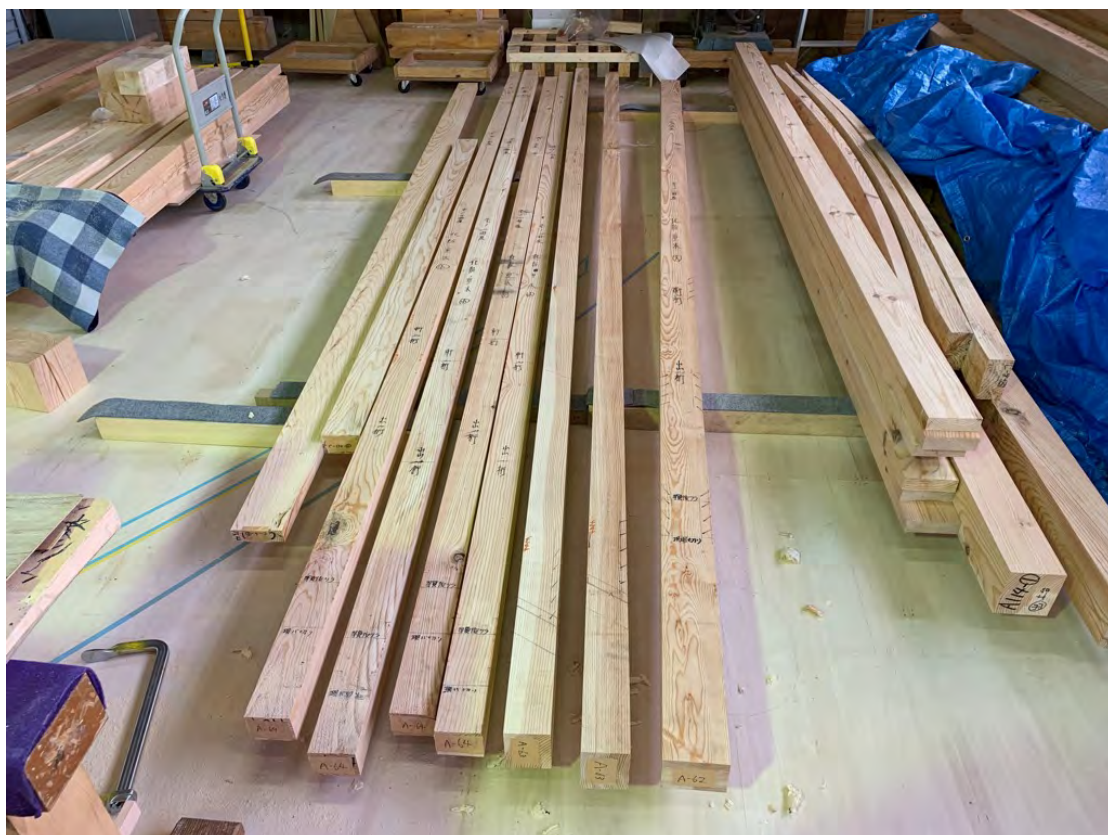
The timbers that started marking and processing.
【upper photo: timbers for roof truss, lower photo: timbers for rafter】

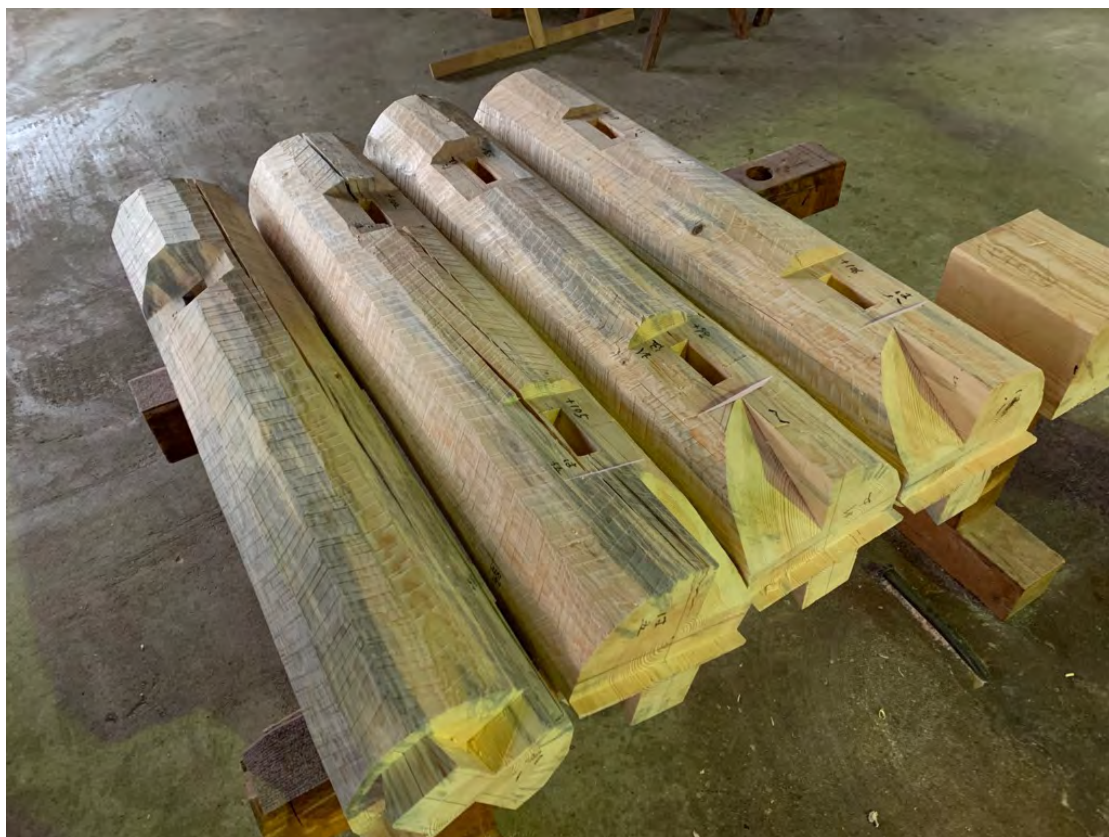
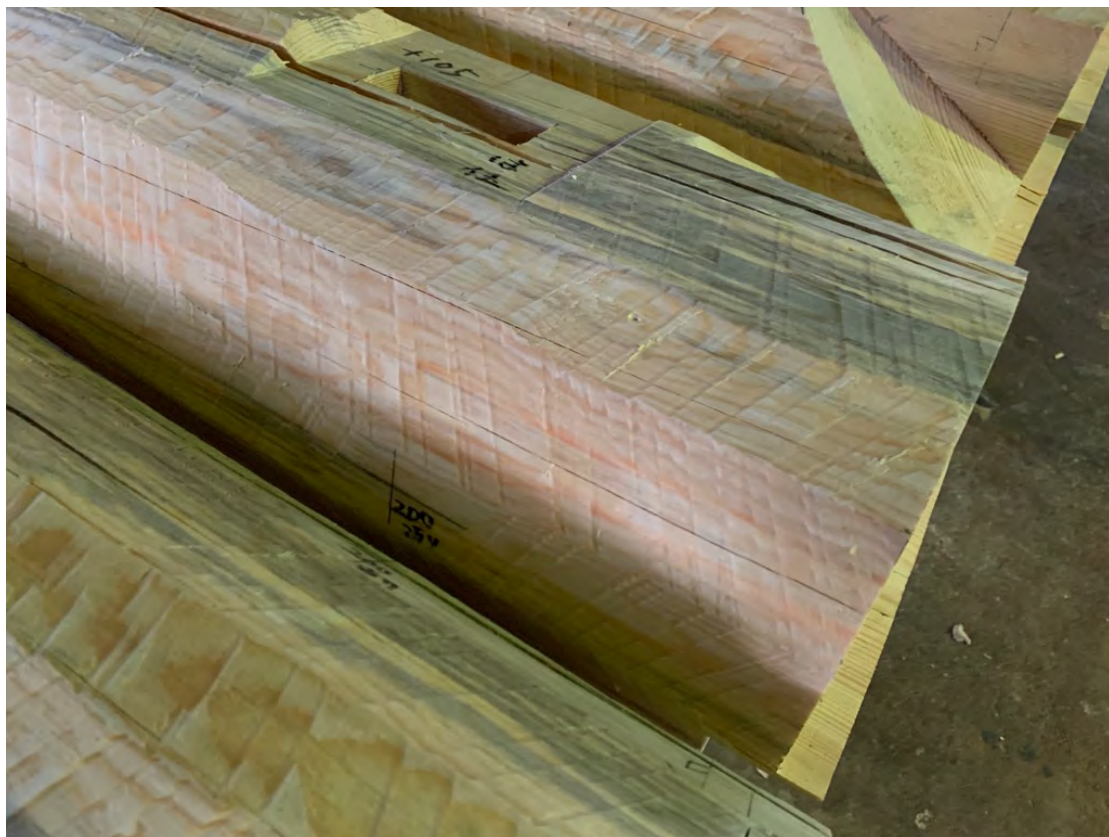
We checked how the timbers that started processing were finished with chouna (adze).

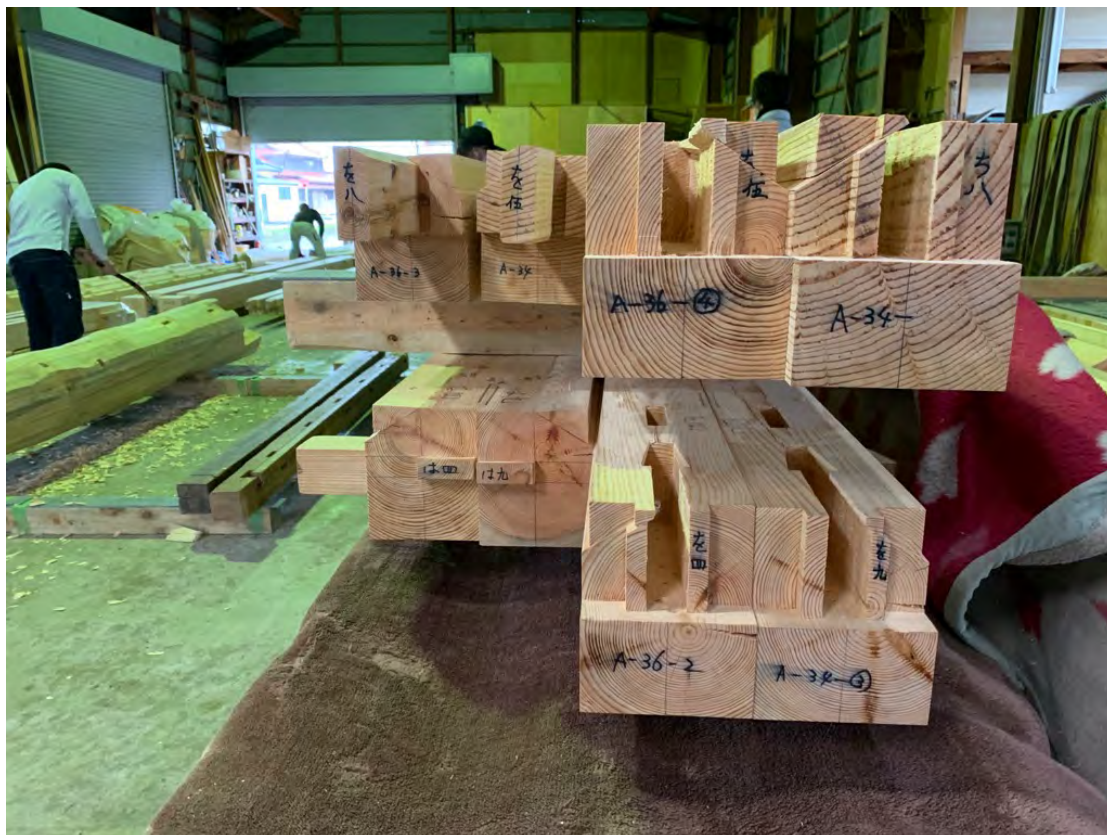
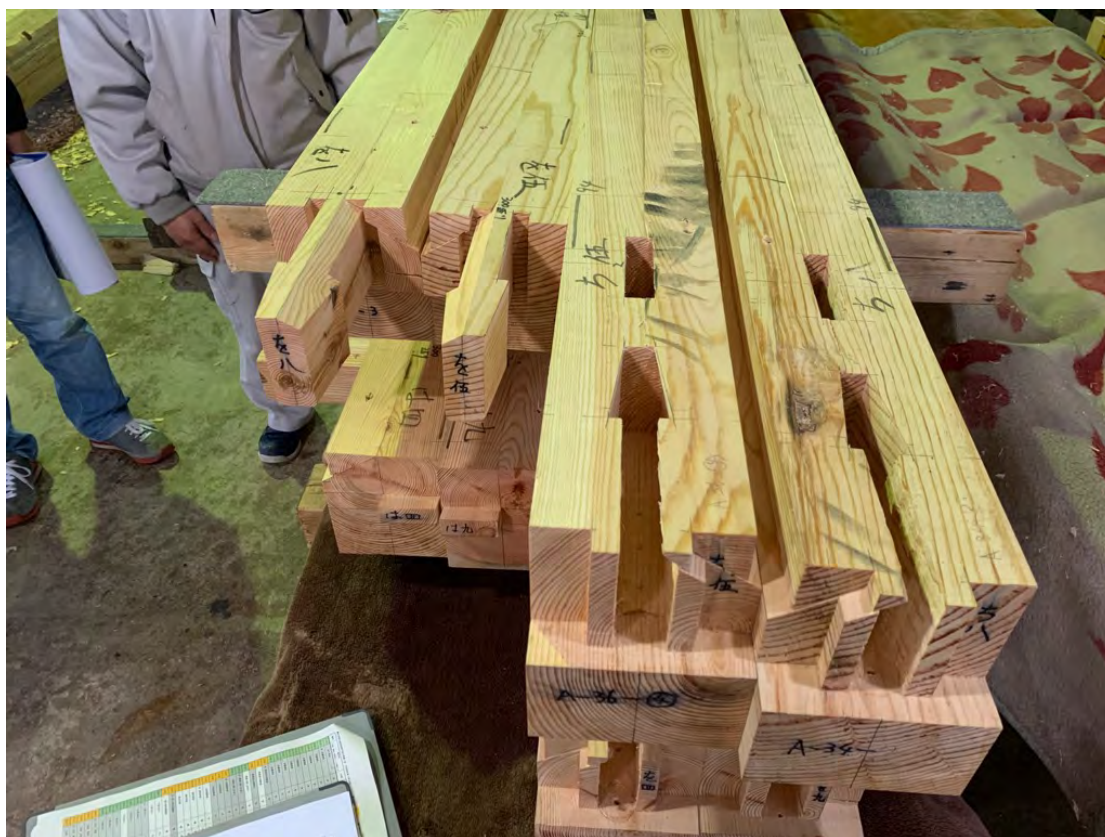
We checked the processing status of the joints.

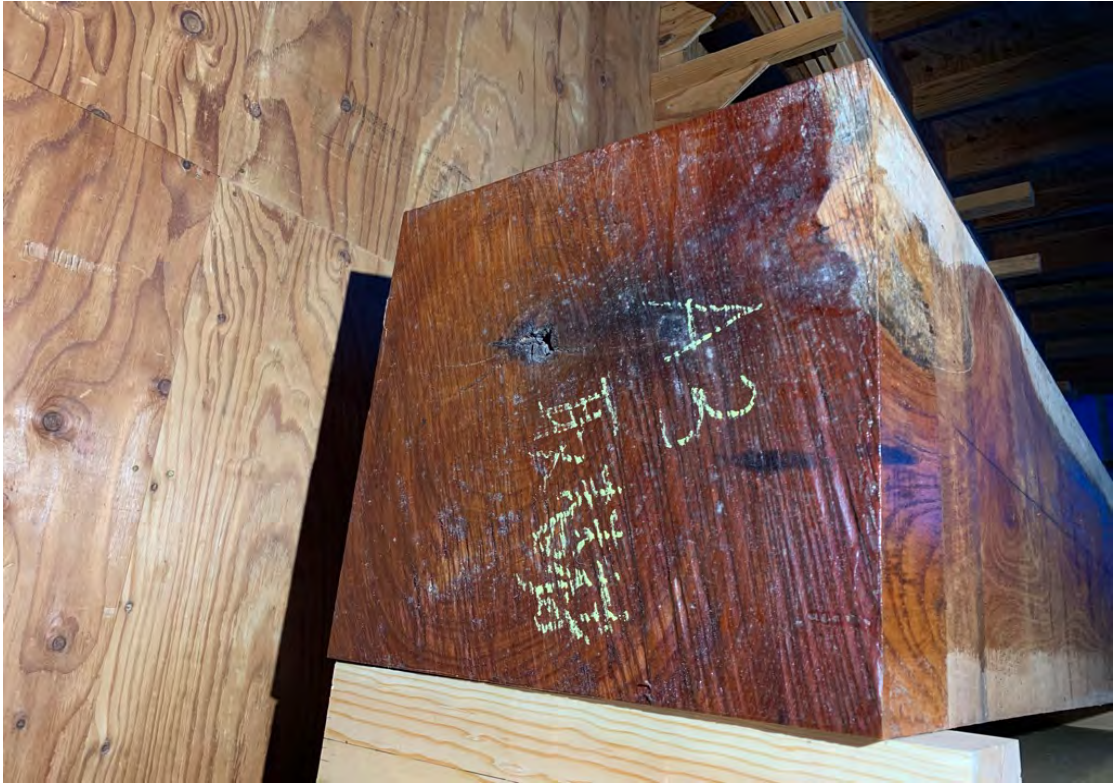
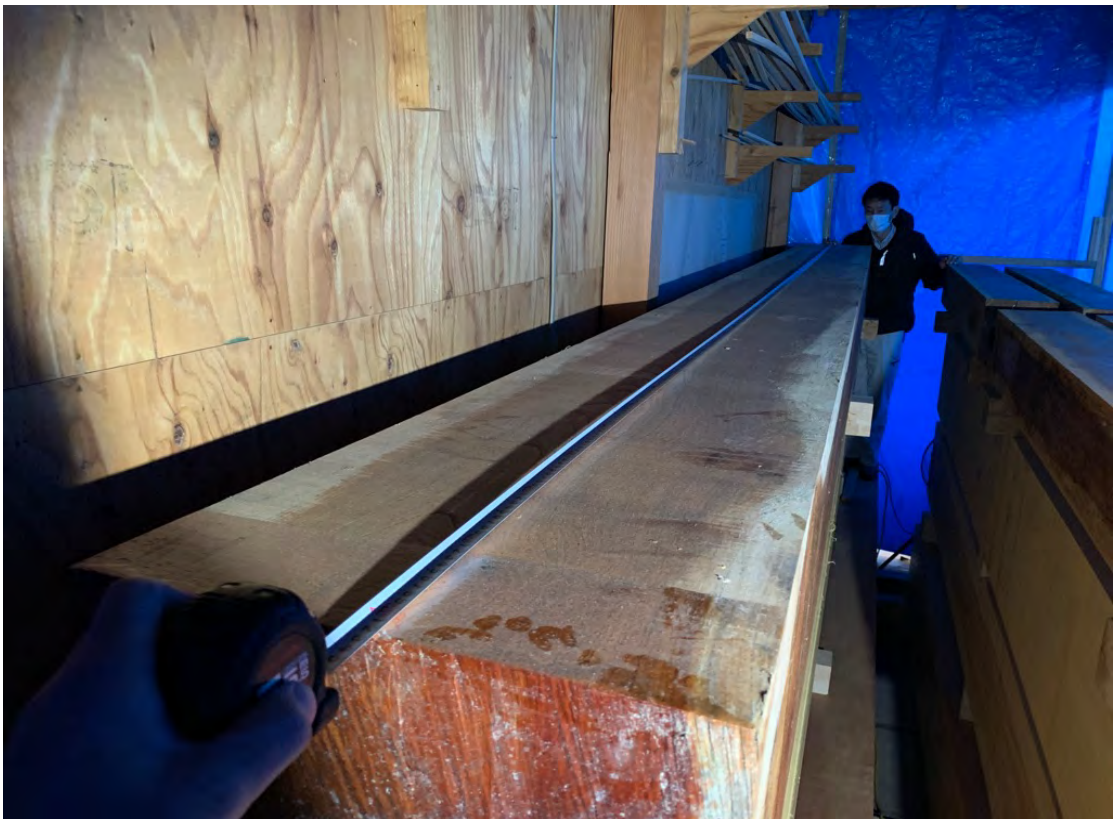
Even if the material has passed the inspection, cracks or twists may be found during the drying period or at the beginning of processing, in which case a new replacement material must be secured. It is the difficulty of treating a natural material.

We also check the quality of the replacement material, and for materials with a high moisture content, we secure a storage place indoors and dry it.
